# **Landslide Hazard Mapping in Norddal, Møre og Romsdal**

*A case study and review of landslide hazard mapping according to current requirements of the Norwegian Water Resources and Energy Directorate (NVE)*

Master Thesis in Geosciences

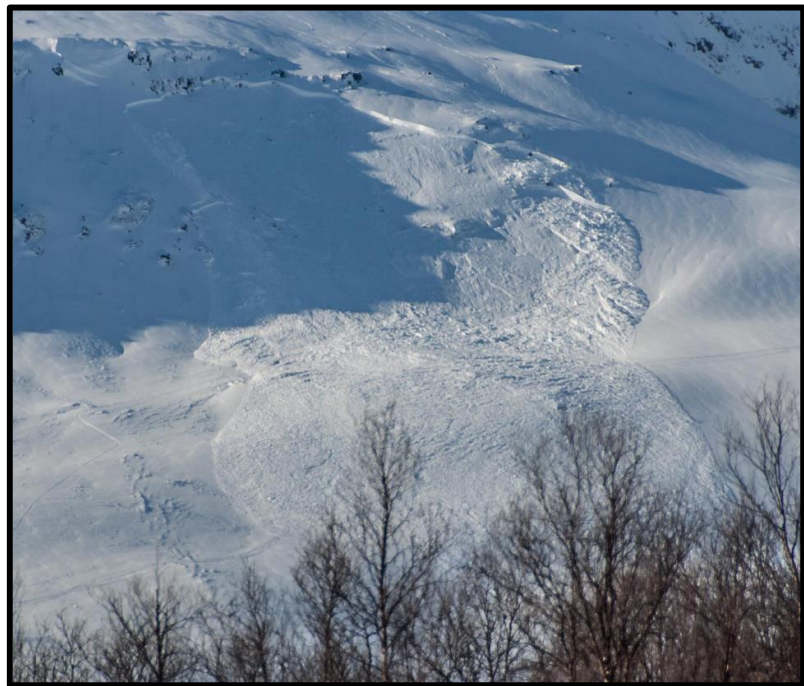
*Figure 2-4: Slab avalanche from Tamokdalen, northern Norway (Photo: Kristin N. Heggland).*

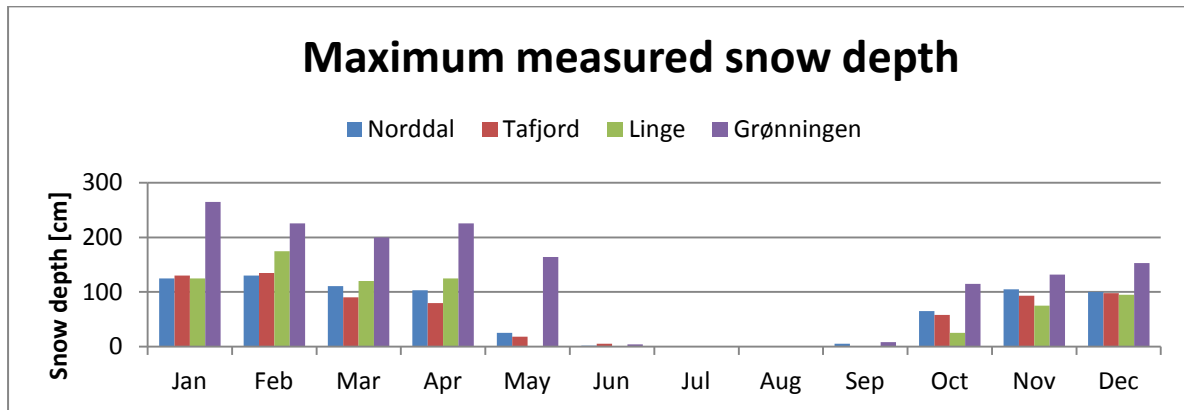
Figure 5-13: Maximum measured snowdepth for Norddal and surrounding stations. Notice the significant higher values for Grønningen, which is located almost 300 m higher. Data from *eklima.no* (2013).

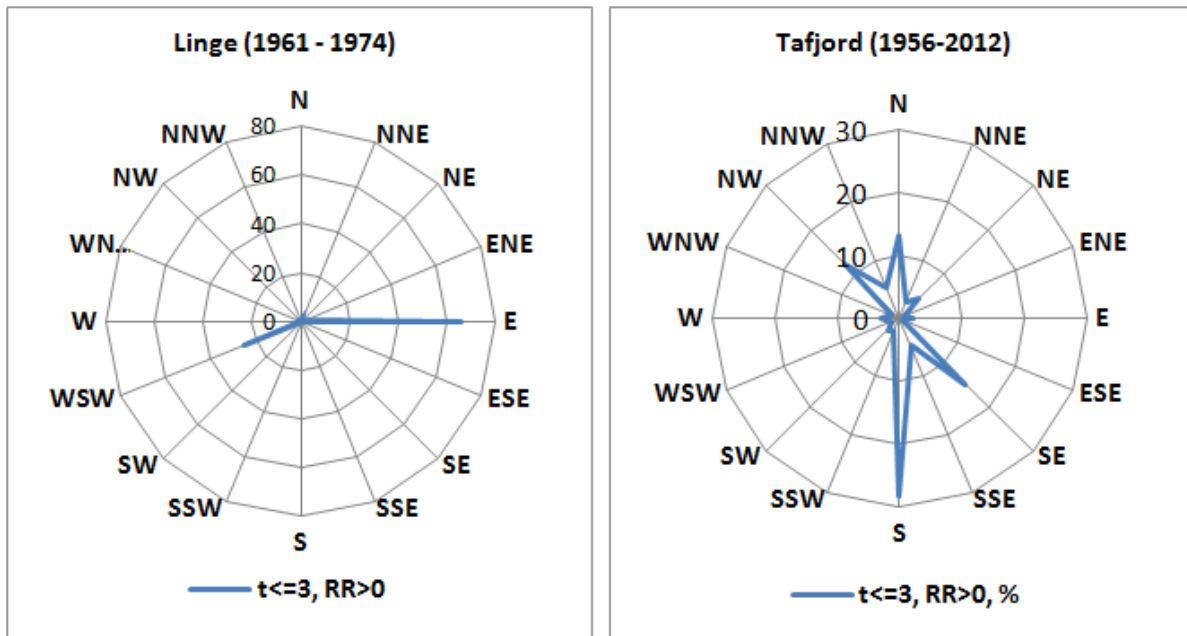
Figure 5-17: Wind distribution during snow fall for Linge (1961-1974) and Tafjord (1956-2012). The wind distribution coincides with local topographic conditions. Data from *eklima.no* (2013).

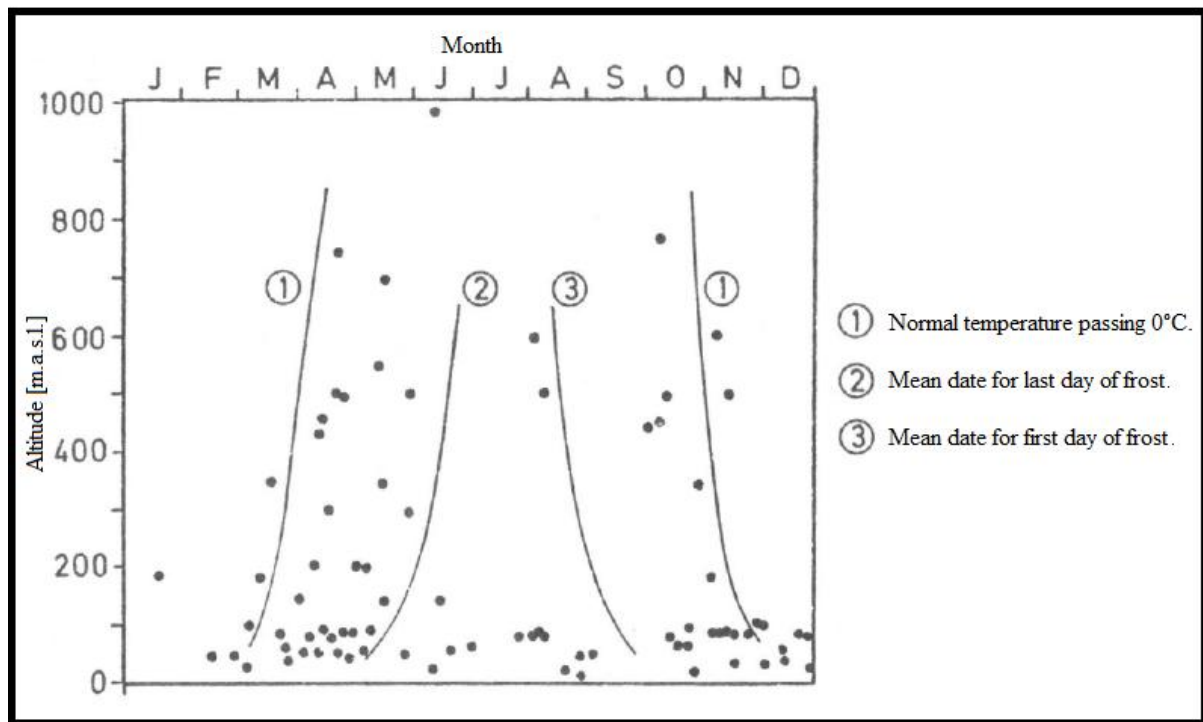
Figure 5-18: Rock falls as a function of season and altitude. The plot shows a strong correlation between rock fall occurrence and temperature alterations around 0°C (Bjerrum and Jørstad, 1968).

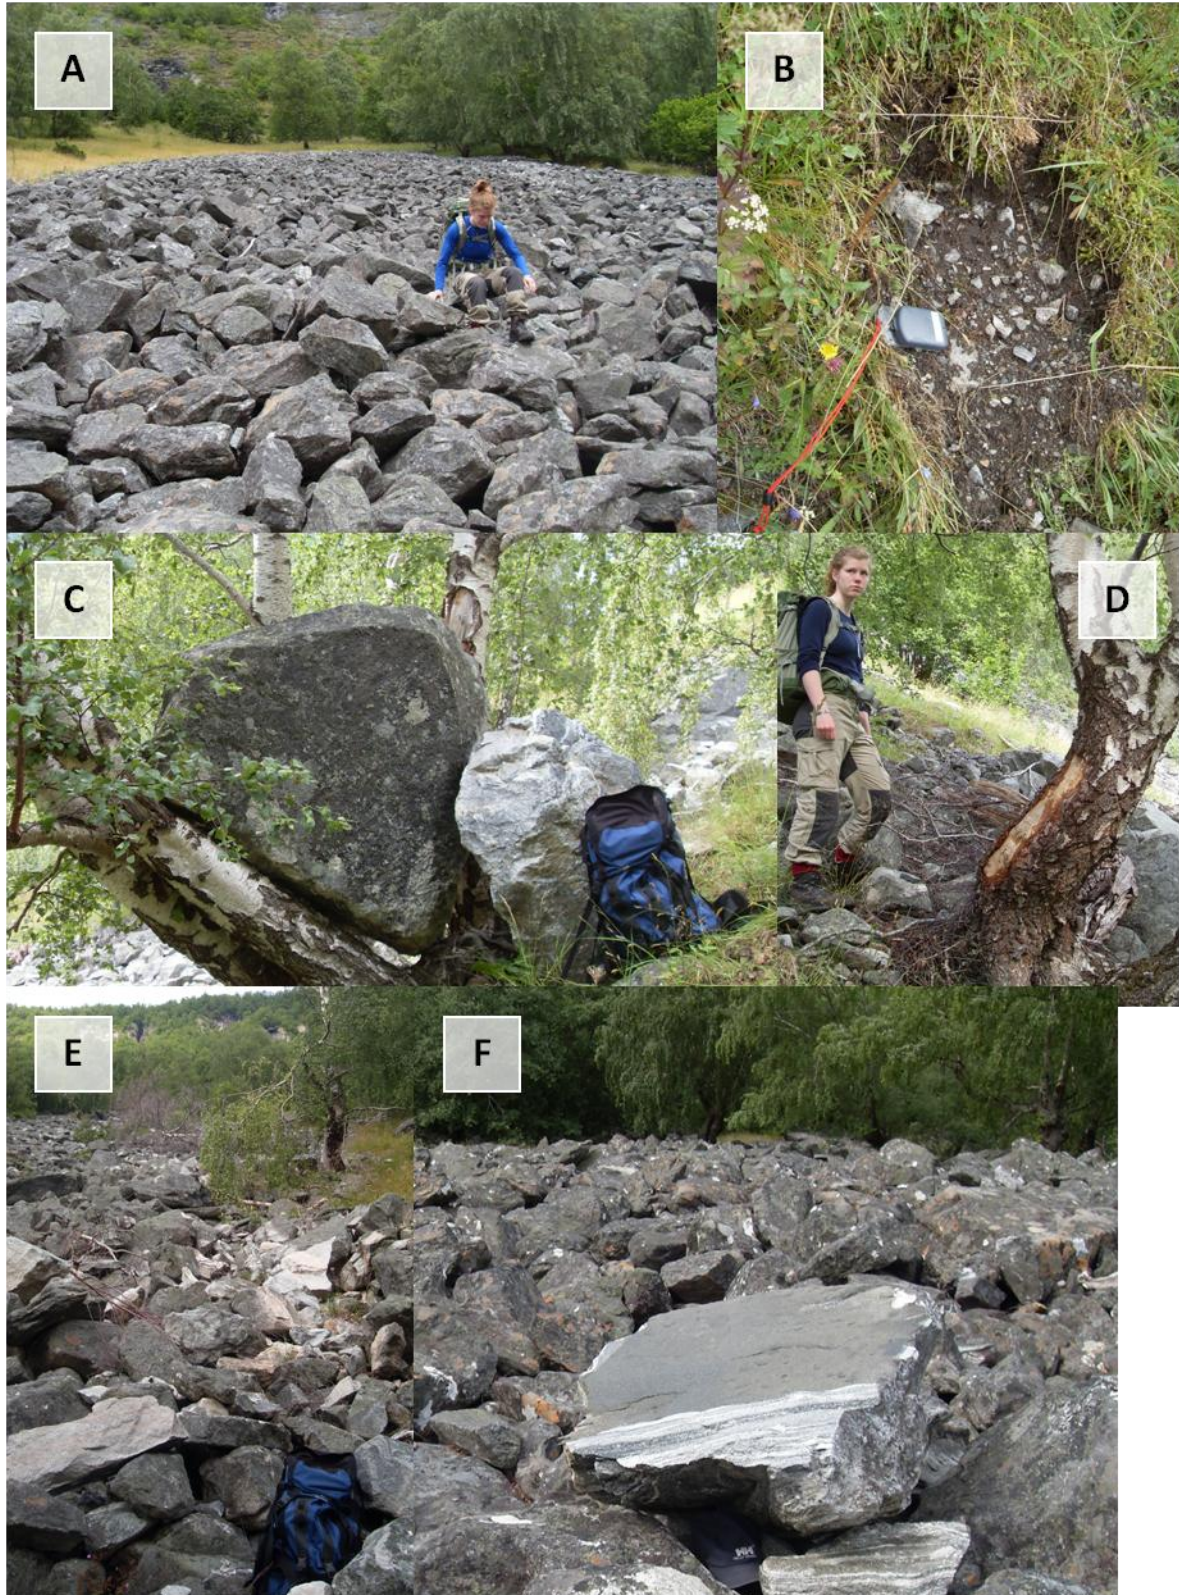
*Figure 6-3: A) Large vegetation free area on the talus, picture taken upwards. B) Trace after rock fall on the upper part of the talus. C) Rocks which have stopped toward a tree. D) Rock fall scar on a tree. E, F) Fresh rock fall deposits (Photos: N. A. Walberg).*

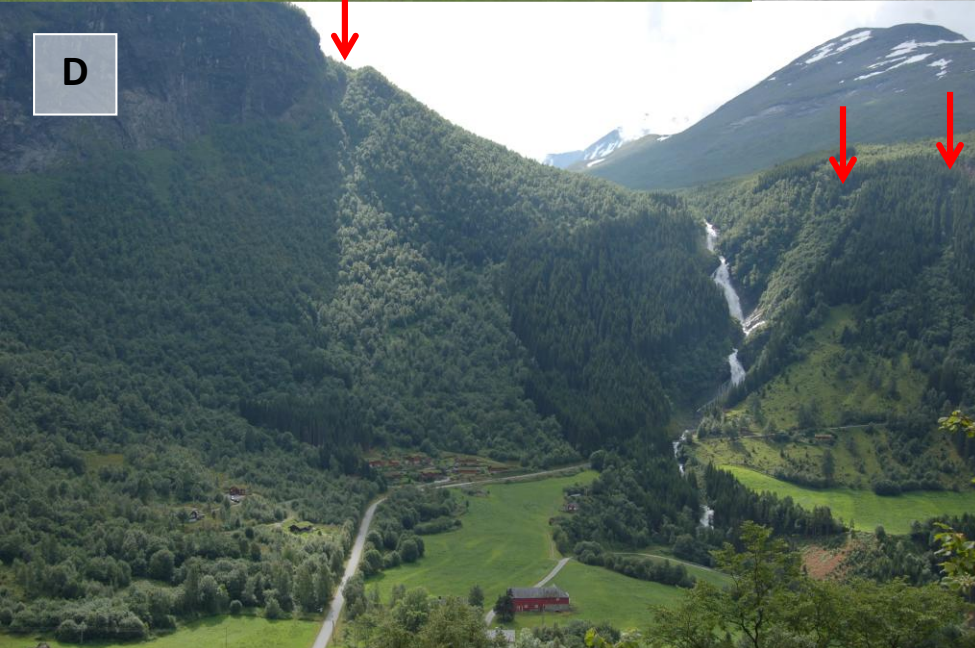
*Figure 7-2 (previous page): A) Glacio-fluvial deposits in the Nordhjellane terrace. Sorted deposits of sand and clay with evident bedding, interrupted by unsorted material, which is thought to be debris slide deposits. Picture from a gravel pit. B) Small slide in an area which today is used for grazing, a common sight in the area. C) Close up photo of the unsorted layer. No sorting and size range from sand to boulders give an indication of the source; till deposits from the above lying valley side, or moraine deposited from a temporary advance during glacial retreat. D) Overview photo of the south-western part of the valley. Daurmålsfjellet is located in the left and an evident ravine is visible right beneath the top (arrow). Also, scars from two debris slides are visible right in the picture. The first dammed the river (#13 in Appendix D), while the second is thought to be the one from 1975 (#2). The latter started by a small forest road in the upper part of the valley side during heavy rain (Photos: N.A. Walberg).*

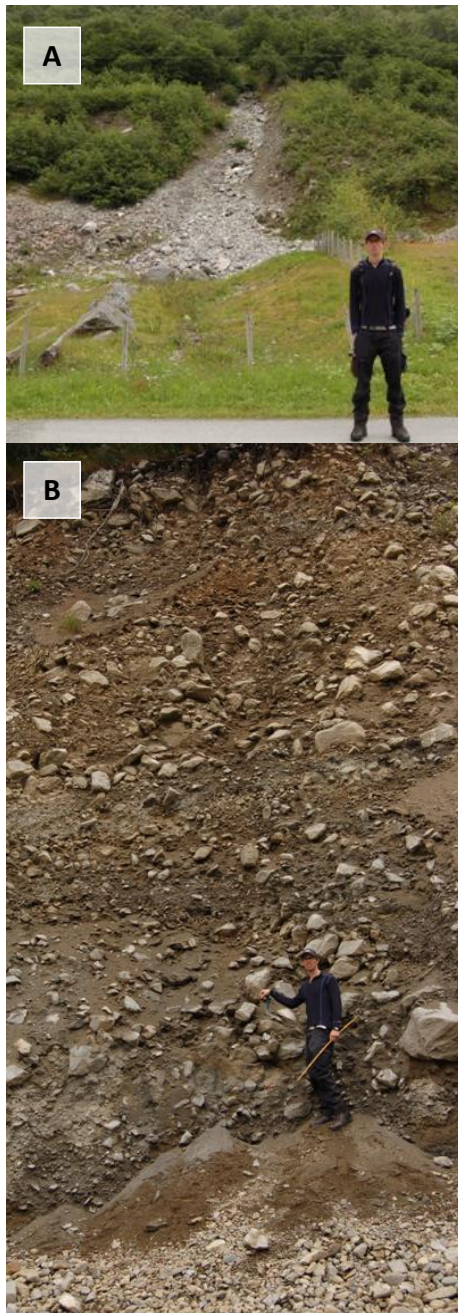
Figure 7-4: A) The lower part of Kyrkjegrova where deposits have been removed to lead new slides away from the settlement. B) Massive deposits from recurring events of debris flows, rock falls and snow avalanches 350 m north of the outermost settlement (Photos: M. Lund).
